**[Docket No. FAA-2019-0692; Product Identifier 2018-NE-19-AD; Amendment 39-19735; AD 2019-18-08]**

#### **Airworthiness Directives; Engine Alliance Turbofan Engines**

in cruise over **Greenland (Denmark)**

## Uncontained failure of engine No 4 en route, diversion

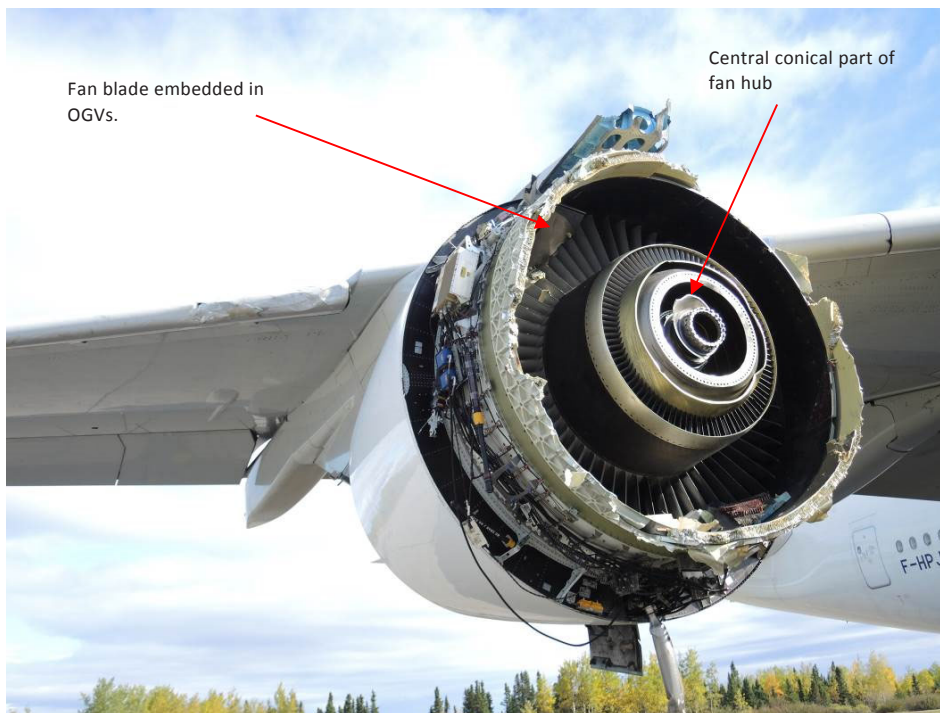
Figure 4: Damaged F-HPJE engine No 4 at Goose Bay

A visual examination of the engine found that the fan, first rotating assembly at the front of the engine, along with the air inlet and fan case had separated in flight leading to slight damage to the surrounding structure of the aircraft.

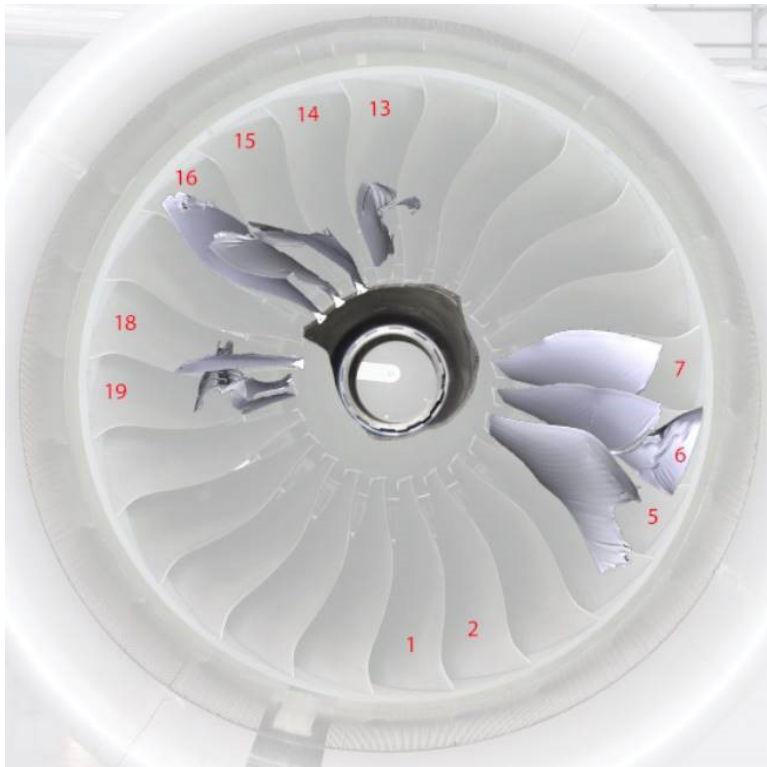
No evidence of progressive failure was observed during these examinations. The fracture surfaces, when they were not damaged, were characteristic of sudden failure due to overload. In addition, no evidence of a bird strike could be observed.

Figure 7: Illustration of fan blades found, when their position is known. Blades 5, 6, 7, 13, 14, 15, 16 and 19 were found on the Greenland ice sheet. Blade 18 was found embedded in the OGVs. The fragments found in the engine at Goose Bay no longer had any identification numbers and could not be positioned on the engine. Position 1 was chosen arbitrarily at the bottom of the engine for illustration purposes.

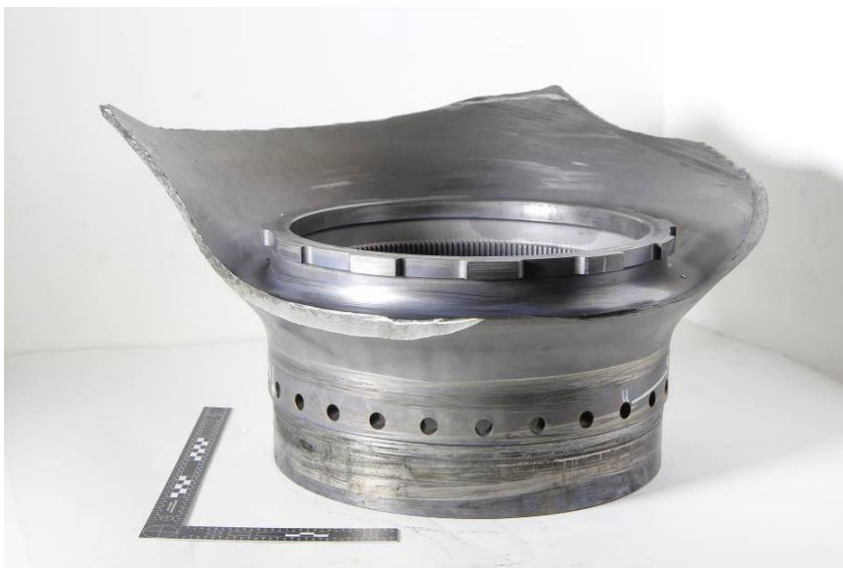
Figure 11: Hub fragment after its removal from damaged engine

The central conical part of the hub ([Figure 11](#)) was still attached to the low-pressure turbine shaft. The fracture surfaces were visually examined and by means of a Scanning Electron Microscope (SEM). They were characteristic of a sudden failure due to overload. The examination of the material's microstructure and its chemical composition did not find any anomaly. The examinations carried out on this fragment were not able to identify the cause of the hub failure.

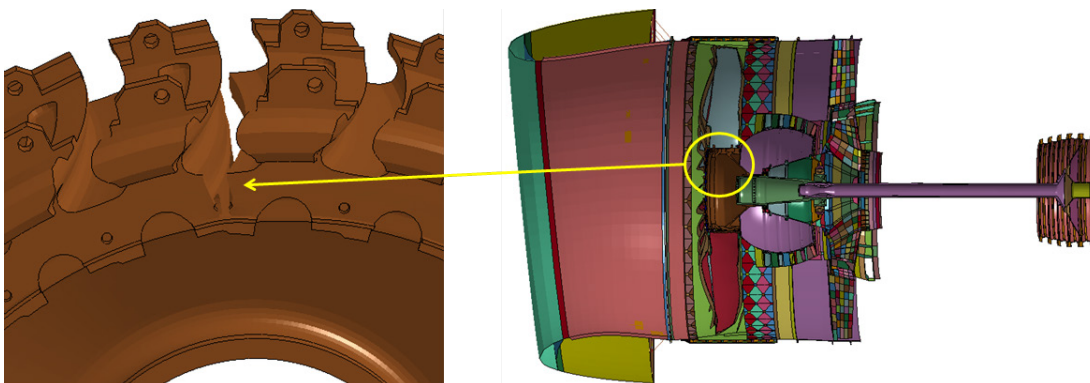
Figure 12: Hub "bore to rim" fracture scenario

In the absence of a hub fragment showing evidence of the origin of the failure, other possible failure scenarios had to be explored. To do this, P&W created a finite element model of the GP7270 fan module in order to carry out dynamic calculations using the LS-Dyna calculation code. This model was first used to assess the different failure scenarios proposed and to provide insight into the observations on the engine. In a second phase, this model was used to determine the probable mass, size and ejection velocities of the hub fragments which would guide the searches for the parts in Greenland. The finite element model included the low pressure rotor system (fan case, intermediate case, low pressure compressor and static casing structure), the low pressure turbine, and the low pressure rotor bearing supports. The physical finite element models that make up the LS-Dyna model utilized calibrated material models and modelling techniques and procedures that had been validated for the P&W engine development programs. These validations were carried out by correlating model results with test results, specifically during Fan Blade Off and Bird Ingestion tests carried out as part of the engine's certification. The material models used in this analysis were elastic-plastic. The model was not a full engine model, but consisted of a sub-set of engine hardware with the goal of evaluating the behaviour of the fan hub and its local surroundings in the fan module. Because of this limitation, the model results were considered valid for only the initial 20-30 milliseconds after the start of the failure sequence. Nevertheless, this time period was able to simulate the events from the initial part fracture until roughly the time at which the hub fragments (for the cases where the hub ruptured) penetrated the fan containment case. As LS-Dyna is not a fracture mechanics analysis, it was necessary to artificially start the event by forcing the initial fracture of the part. Several scenarios were analysed, the one which was the most consistent with observed damage on engine No 4 was the fan hub "bore to rim" fracture ([Figure 12](#)).

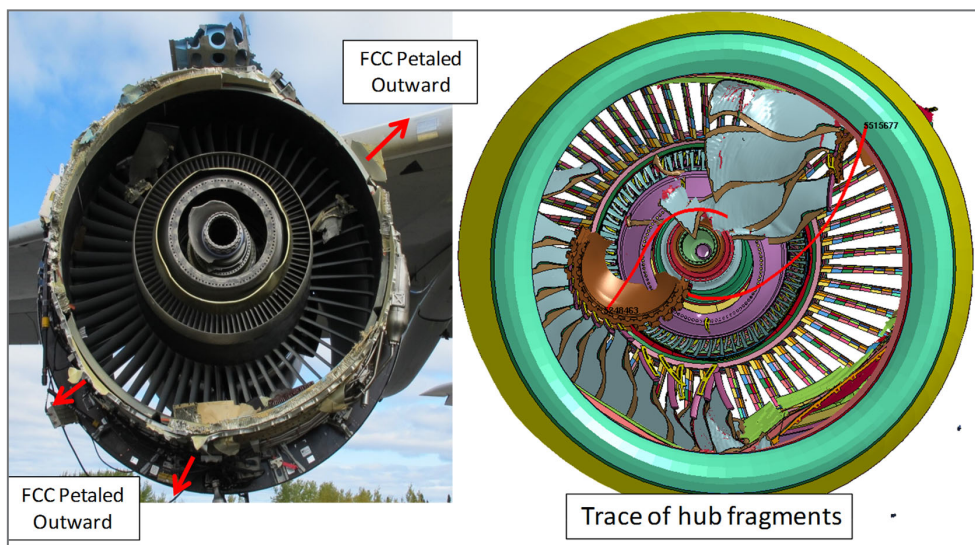
Figure 13: Simulation of fan hub “bore to rim” failure

The collateral damage and part fragmentation associated with the fan hub “*bore to rim*” fracture in the simulation were consistent with the hardware findings observed on engine No 4. In particular, the fan containment case damage, Kevlar® belt damage, low pressure compressor drum front face damage patterns, and the condition of the fan blades recovered both from the ground in Greenland and in the engine (Figure 13) supported this scenario.

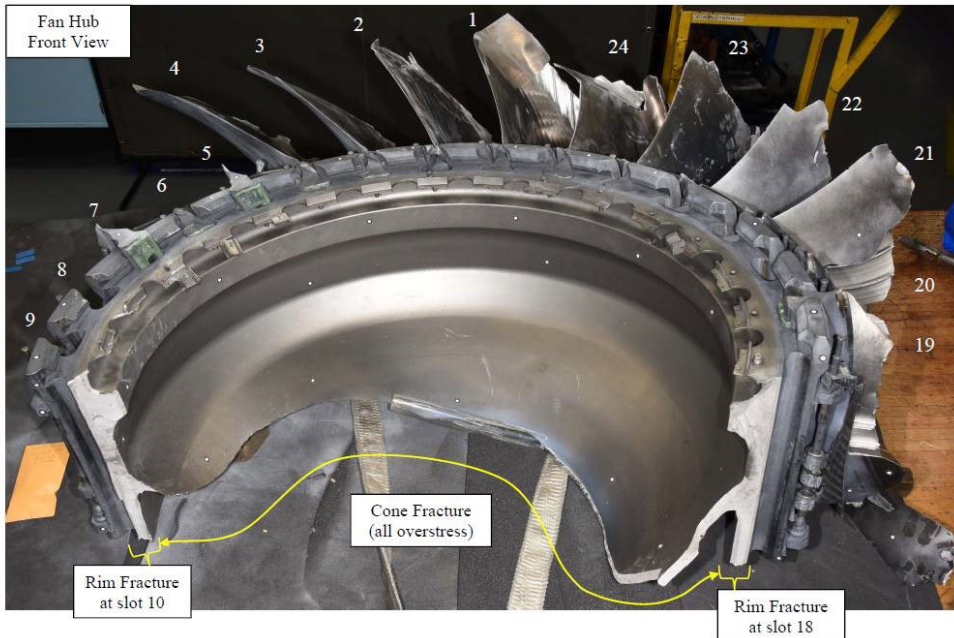
Figure 16: fan hub fragment found in Greenland during phase III. The slot numbers are given in white. The fracture surface extends from the bottom of slot No 10 to slot No 18, passing through the conical part of the hub (yellow line).

The examination determined that the hub failure was caused by a LCF<sup>(19)</sup> cracking process which originated in the part's subsurface. The origin of the crack was located practically in the centre of slot No 10 ([Figure 17](#)), around 14 cm (5.6 inches) behind the front face of the hub and 1.4 mm (0.055 inches) below the surface of the slot bottom. No material quality (composition, microstructure) or manufacturing related anomaly was found.

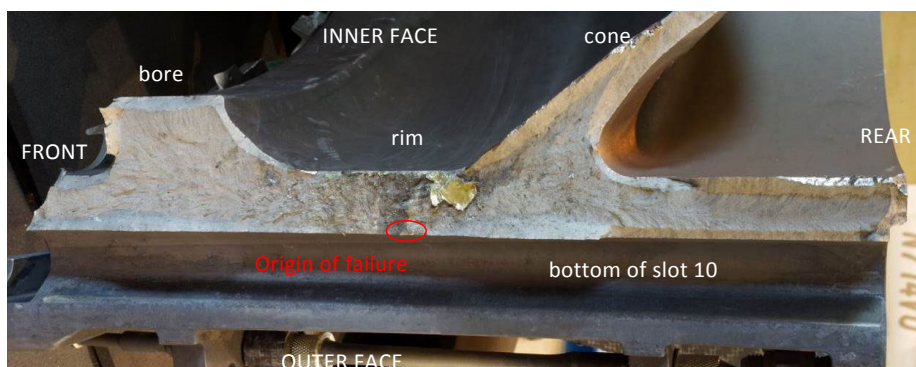
Figure 17: Fracture surface of slot No 10

A region of fatigue striations, characteristic of LCF progression was observed between the origin of the failure and the hub's inner face. The striations were evenly spaced at distances of between  $25.4 \times 10^{-5}$  mm/cycle and  $25.1 \times 10^{-4}$  mm/cycle ( $\sim 1 \times 10^{-5}$  inch/cycle and  $\sim 9.9 \times 10^{-5}$  inch/cycle respectively). The grains situated between the origin of the failure and the surface of the slot bottom chiefly had near-cleavage<sup>(20)</sup> facets (faceted growth) with the occasional presence of striations. P&W counted the number of striations in order to determine the number of progression cycles required for the crack to become a fracture. The hypothesis that one striation equals one aeroplane cycle is generally accepted in LCF for rotor parts essentially subject to centrifugal loads. To do this count, different striation images were taken with the Scanning Electron Microscope (SEM), at different distances from the origin, from 0.076 mm to 1.7 mm (0.003 to 0.068 inches). On each image, the ratio of number of striations per millimetre was calculated by dividing the number of striations observed by the distance separating the first striation observed from the last. However, some of these images were taken in mixed zones where there were also faceted growth. A method was used to determine the ratio between the two fracture modes (cleavage and striations) and to adjust (reduce) the number of progression cycles according to this fracture mode ratio. The total number of striations was assessed at 1,652. During this operation, it was observed that there was a transition zone from which the definition of the striations got better. This zone was attributed to the transition between crack progression in a vacuum and progression in the air, i.e. it indicated the moment when the crack reached the surface of the slot and became surface connected. This zone was situated at around 0.41 mm (0.016 inches) from the origin and corresponded to 773 cycles. This means that a little less than half of the stable progression of the crack, in number of cycles, occurred in a vacuum, subsurface.

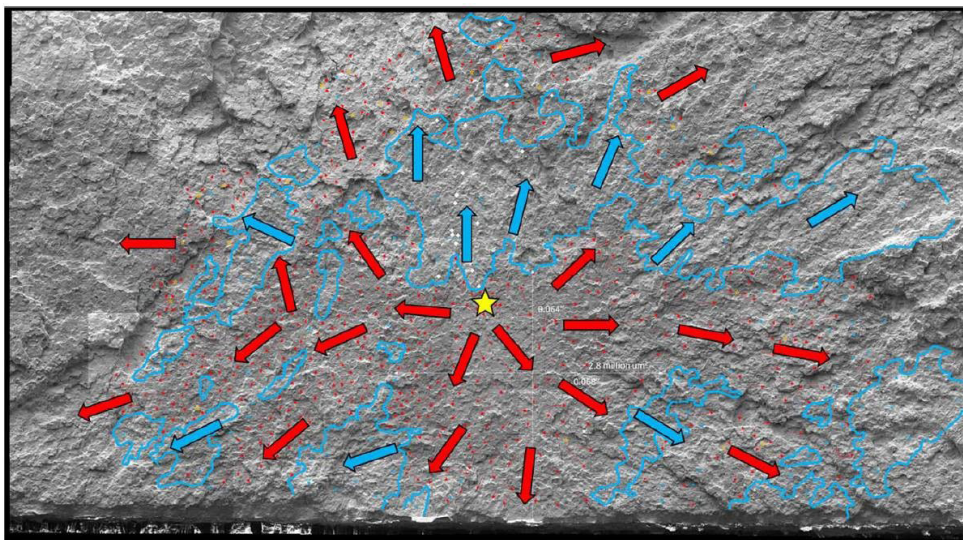
Figure 18: SEM detail view of origin of fracture. The red arrows show the crack growth direction in the faceted regions and the blue arrows the growth direction in the striated regions. Areas where the striations are predominant are outlined in blue. The orientations obtained confirm the existence of a primary origin at 1.4 mm below the surface of the slot bottom (yellow star) in a predominantly faceted region.

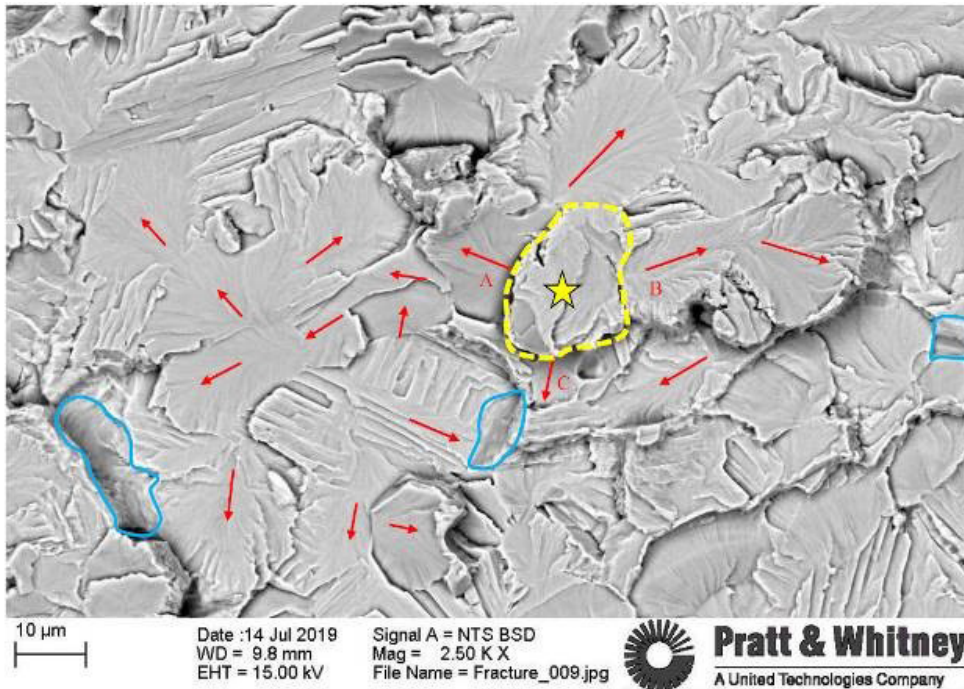
Figure 19: SEM view of origin of fracture (faceted growth region). The red arrows indicate the growth directions. The grains A, B and C exhibit a crack progression direction away from a small area covered by a flap (yellow dotted line). The grain under the flap was revealed using a Focus Ion Beam (FIB).

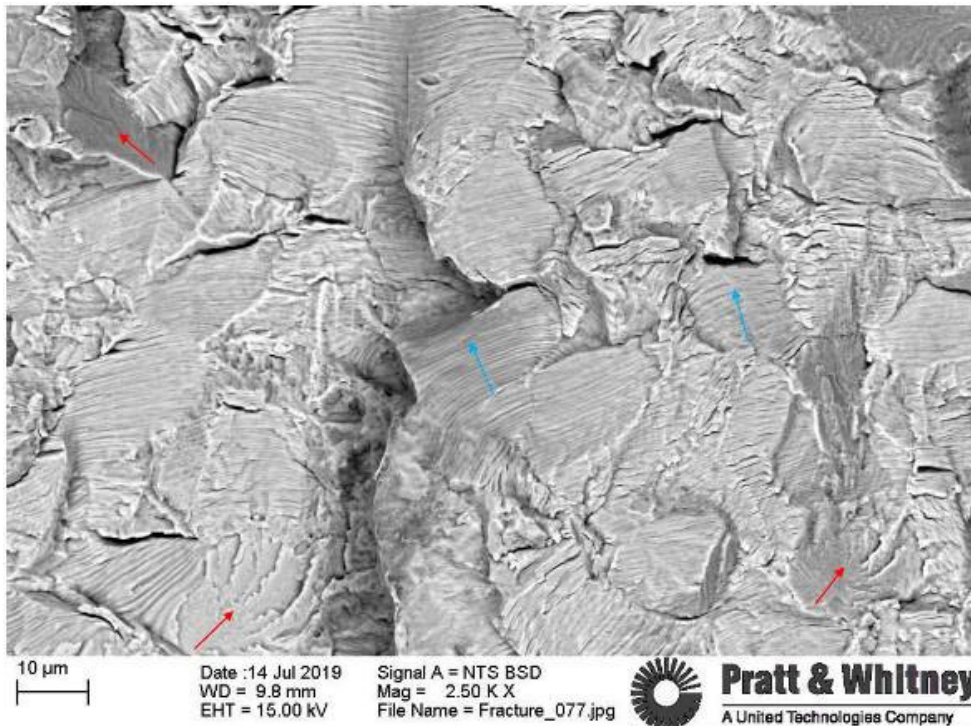
Figure 20: SEM view of a predominantly striated region. The crack progression direction in the striated regions is shown by the blue arrows. Near-cleavage facets were also present (red arrows).

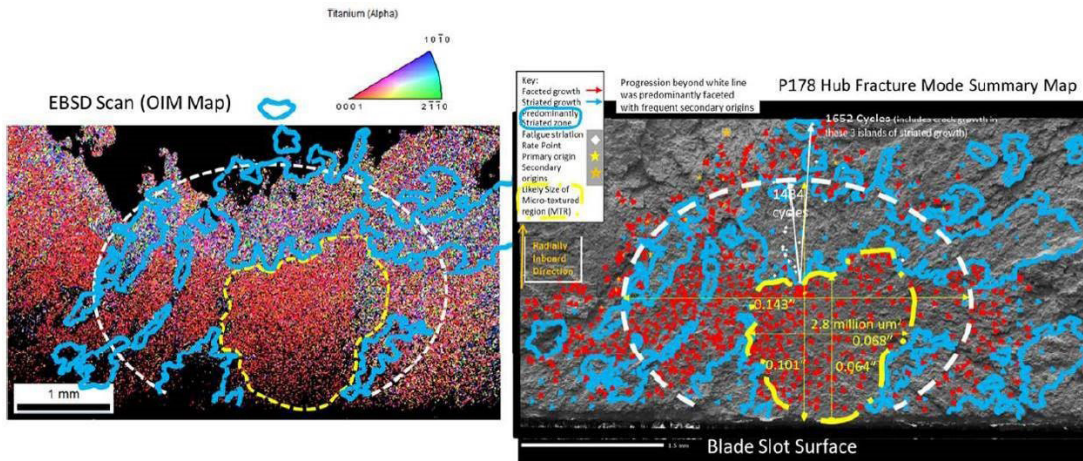
A strong correlation was found between the map showing a region with predominantly basal oriented  $\alpha$  grain, perpendicular to the hoop stress (yellow dotted line in left image [Figure 21](#)) and the location of the predominantly faceted region (yellow dotted line, right image [Figure 21](#)).

Figure 21: Origin planar micro of fracture showing the crystallographic orientation map (on left) obtained with EBSD after light polishing into the fracture surface. The red regions correspond to grains which have their basal planes oriented perpendicular to the hoop stress direction through the hub rim.
