**[Docket No. FAA-2019-0692; Product Identifier 2018-NE-19-AD; Amendment 39-19735; AD 2019-18-08]**

#### **Airworthiness Directives; Engine Alliance Turbofan Engines**

in cruise over **Greenland (Denmark)**

## Uncontained failure of engine No 4 en route, diversion

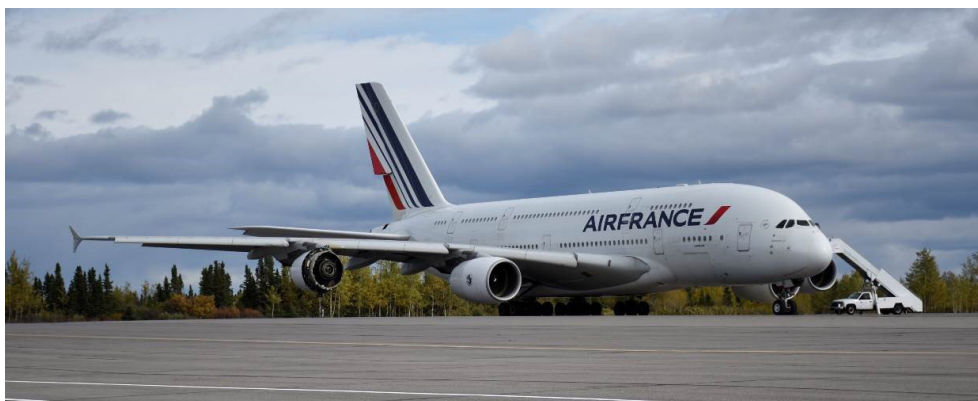
Figure 3: F-HPJE after landing at Goose Bay

The aeroplane touched down without any particular difficulty at Goose Bay airport in Canada ([Figure 3](#)).

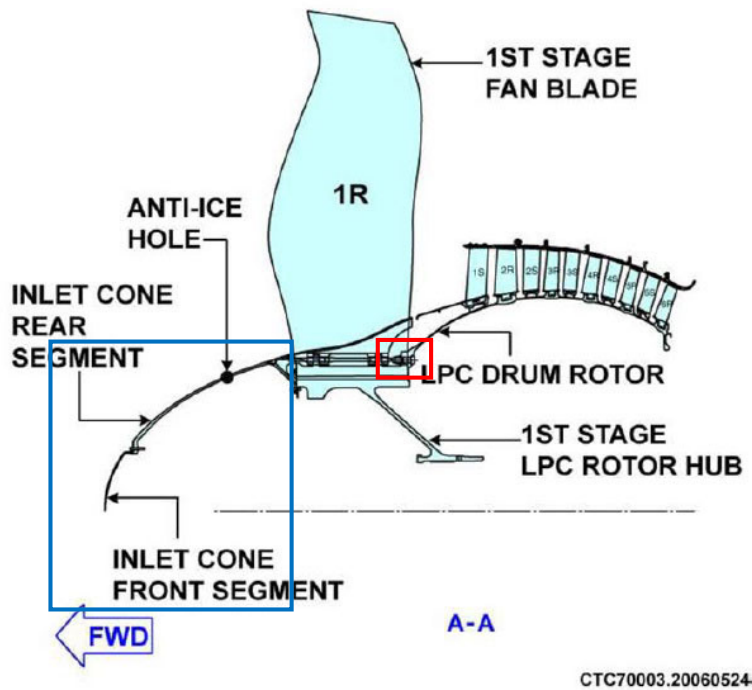
Figure 6: Cross-section of LP compressor of GP7270. The red rectangle identifies the bolts attaching the fan hub to the LP compressor drum. The blue rectangle identifies the inlet cone.

The bolts attaching the fan hub to the LP compressor drum ([Figure 6](#)) along with the markings on the front face of the drum were examined to help understand the failure scenario. The analysis of the bolt shearing directions and the markings on the drum brought to light two clearly distinct bolt groups. This observation was interpreted as being the result of the fan hub fracturing into two fragments (without counting the conical part still integral with the low-pressure shaft).

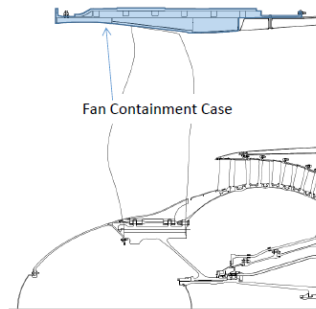
Figure 8: Diagram of fan case and its components

The fan containment case of the GP7200 engine ([Figure 8](#)) is composed of two Kevlar® belts made up of several layers (an inner belt and an outer belt) plus an environmental wrap. All of the Kevlar® case was found on the Greenland ice sheet during phase I of the searches.

P&W examined the Kevlar® belts in March 2018. The result of this examination was compared with the observations on the engine.

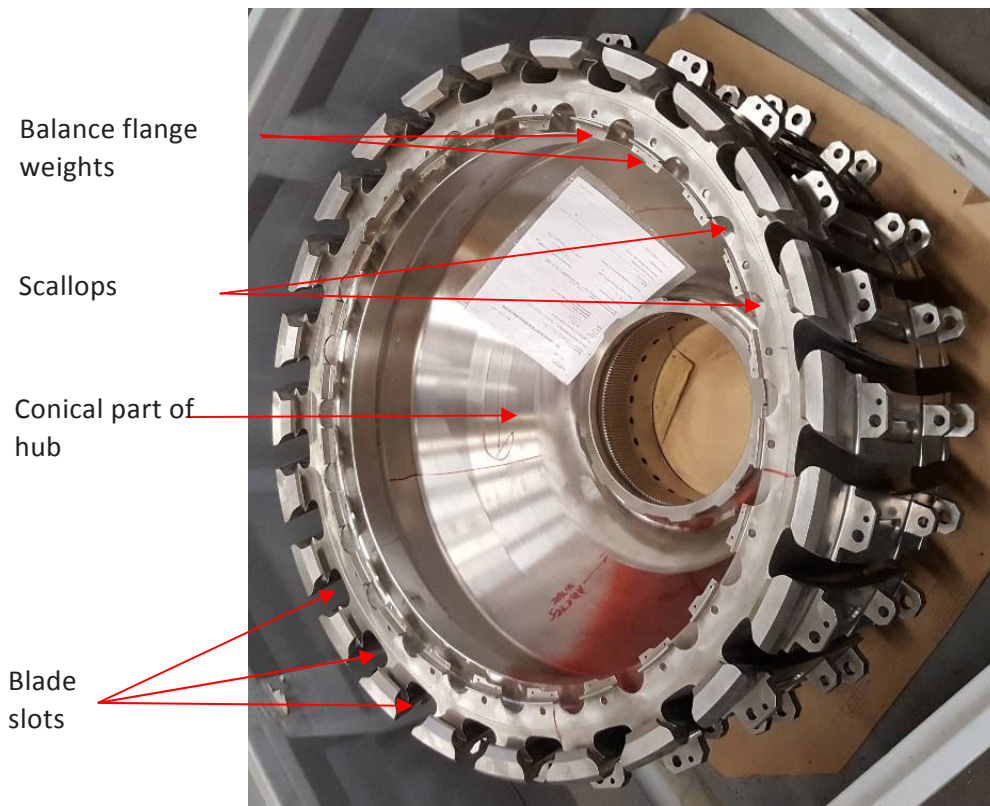
Figure 10: fan hub exemplar. The centre of the conical part is connected to the LP shaft. It is topped by a thicker cylindrical part with 24 machined blade slots.

The GP7200 fan hub is forged from a titanium alloy Ti-6-4 billet<sup>(12)</sup>. This alloy is obtained by a triple vacuum arc re-melt (VAR) process.

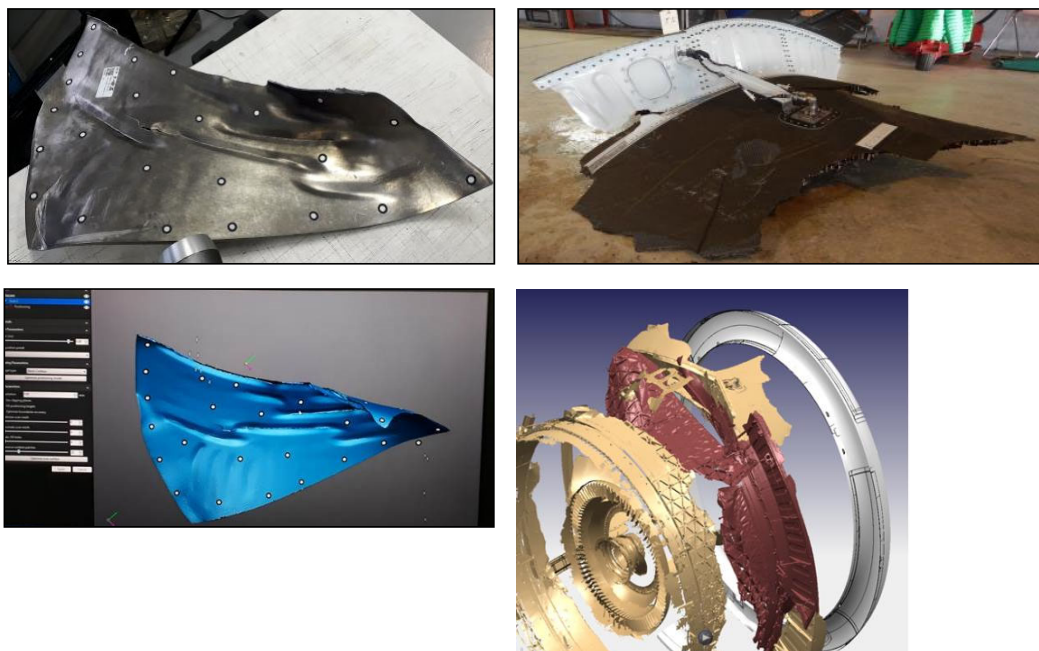
Figure 14: fan blade during scan (top left) and result of scan (bottom left). Part of inlet cowl aft bulkhead (top right) and result of scan (in red, bottom right) inserted in a more complete 3D model of the damaged engine.

One of the main results was the obtaining of the extent of the deformation of the scanned parts. This information was compared with the results of the software simulations in order to reinforce certain failure scenarios in the absence of the fan hub.

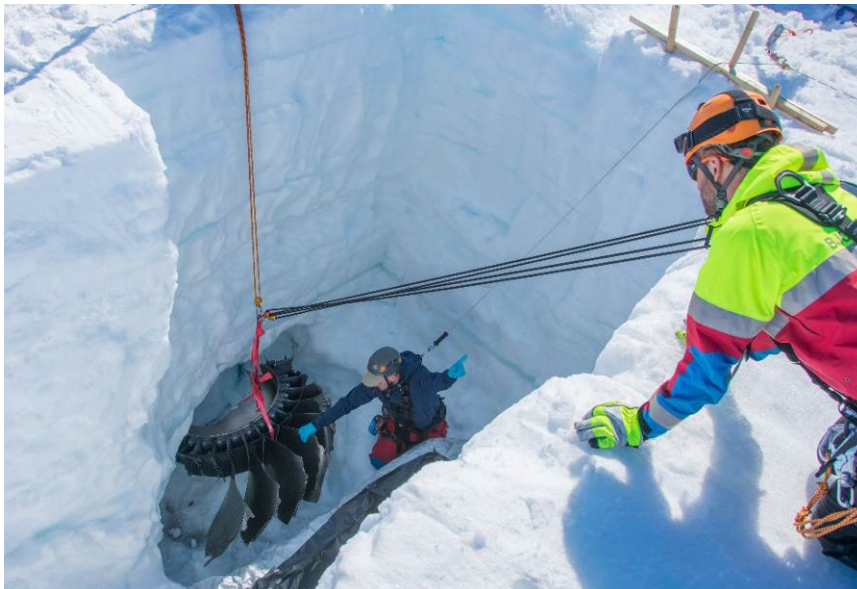
Figure 15: Extraction of fan hub fragment

The finite element simulations carried out by P&W at the beginning of 2018, based on the hypothesis of a fan hub “bore to rim” fracture, provided information about the probable size, weight and ejection speeds of the hub fragments. New ballistic calculations were carried out based on this refined data in order to reduce the size of the search zone. At the end of 2018, the electromagnetic detection system developed by the HydroGeophysics Group (HGG) of Aarhus university (Denmark) was modified so as to be able to detect a titanium part at a distance of five to six metres under the snow. In parallel, the post-processing of the SETHI Radar data acquired during phase II had been completed. ONERA sent the coordinates of a high-probability target and of two less obvious targets to the investigation team. The decision to carry out a new expedition was taken at the end of February 2019 for a departure in May 2019. The expedition kick-off was delayed due to weather conditions which were incompatible with the mission. Despite this hold-up and the resulting reduction in the mission’s duration, an unambiguous detection was obtained at the very end of the campaign at the most promising spot indicated by ONERA. A signal about two orders of magnitude higher than that obtained for the buried test hub was recorded close to the spot where the GPR had already made a detection, indicative of buried metal. The detection was situated one metre north of a four-metre wide crevasse which had a six-metre thick bridge. An excavation campaign was organized in June 2019. A fan hub fragment was carefully extracted and transported to Narsarsuaq airport. The fragment returned a signal to the system used by HGG which was a lot stronger than that of the buried test hub, in part due to its larger size and shallower burial depth. The blades still attached and the presence of other materials (aluminium and steel) may also have increased the signal strength. The part was handed over to the BEA in July 2019 and examined at the engine manufacturer’s, P&W, in order to determine the cause of the failure.

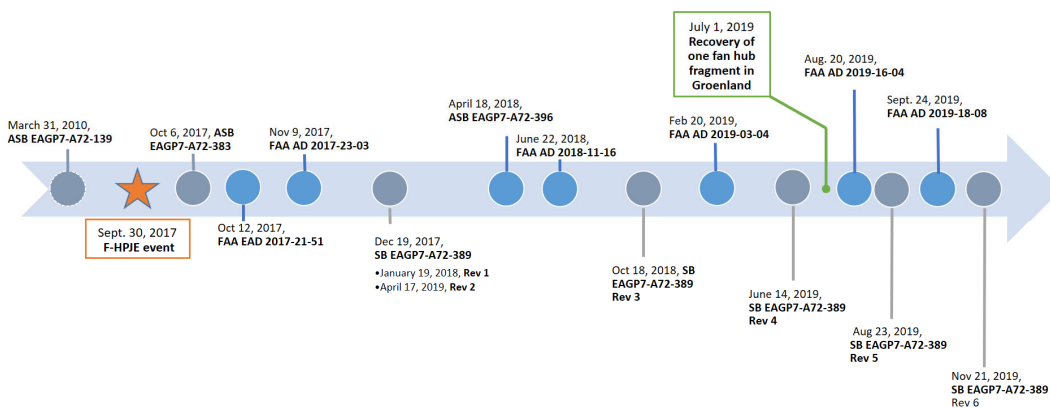
Figure 23: Publication sequence of documents concerning fan hub inspection (time scale not respected)

Following the accident to F-HPJE, Engine Alliance, the FAA and EASA published several documents to reinforce these inspections and to provide the operators of the GP7000 engines with information and instructions. These documents are shown in [Figure 23](#).

On 6 October 2017, EA published Alert Service Bulletin EAGP7-A72-383 which required a one-time visual inspection of the fan hub to search for damage such as nicks, dents or scratches on the visible parts of the hub after removal of the engine inlet cone. The hubs with damage outside the limits given in the ASB were to be removed from service and the damage assessed by EA. This ASB superseded ASB EAGP7-A72-139 issued in 2010.

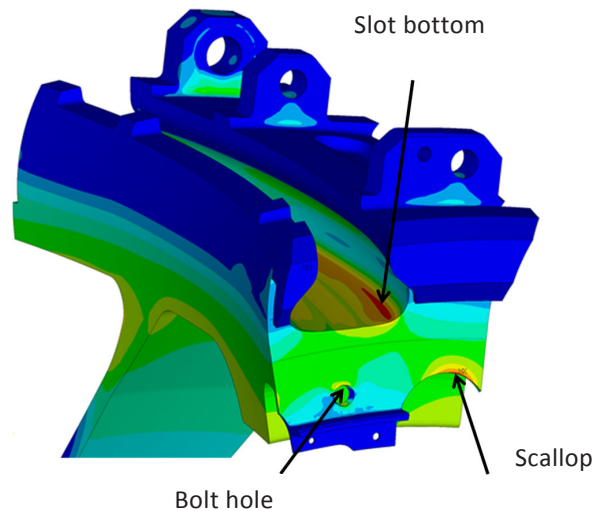
Figure 24: critical zones in LCF (step climb)

P&W determined the critical zones of the hub in terms of LCF. These were the scallops, bolt holes and slot bottoms, as shown in [Figure 24](#): critical zones in LCF (step climb). The maximum stress conditions in the hub occur during step climb, when the fan rpm reaches its maximum speed. Over 600 specimens and 17 components were used to create P&W’s approved lifing system. According to the manufacturer, all specimens, when tested close to the maximum stress level of the critical zones, had lives above 58,000 cycles. Data was also available for stress levels above these maximum calculated values.

The safe life<sup>(24)</sup> of the hub (i.e. LCF life to initiation of a 0.79 mm or 1/32 inch crack) was established to be 15,000 cycles based on B0.1 LCF data.

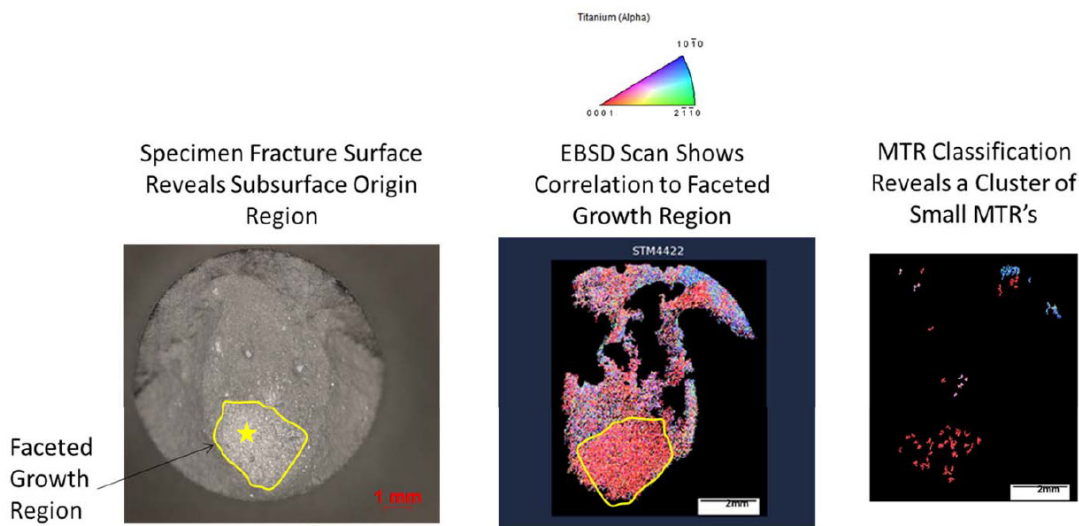
Figure 25: fracture surface of Ti-6-4 test specimen after cold dwell fatigue test (2 minute dwell) on left, with a subsurface fatigue progression region (outlined in yellow). The start of the crack is shown by a yellow star. The crystallographic orientation map obtained with EBSD (centre) was obtained on the opposite fracture surface. It is thus a mirror image of the left figure. The classification of the macro-zones is shown in the right image. The fatigue zone has macro-zones of an average size of  $1.8 \times 10^4 \mu\text{m}^2$ , of a maximum size of  $7.8 \times 10^4 \mu\text{m}^2$  and of a maximum intensity of 0.19.

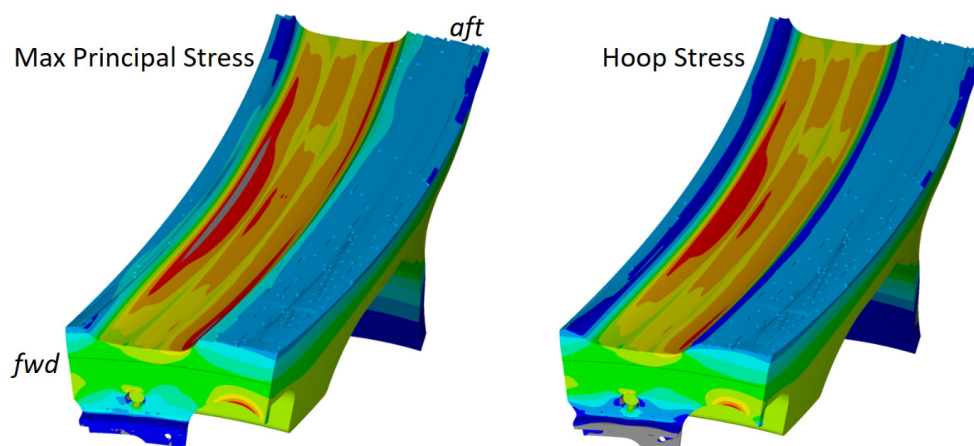
Figure 26: Maximal principal stress (left) and hoop stress (right) in a slot bottom

The fracture started in the subsurface slot bottom, close to the centre of the slot. The crack progressed perpendicularly to the hoop stresses caused by the centrifugal loads applied to the hub. This zone is not the zone with the highest stress. The critical zones in LCF defined by the manufacturer are situated on the hub front face (Figure 24) where maximum stresses are locally a lot greater. However, the crack's initiation area corresponds to a local high stress region (Figure 26). The presence of a subsurface macro-zone in the slot bottom probably contributed to the initiation of a crack in this zone which is subject to lower stresses than those of the critical zones.

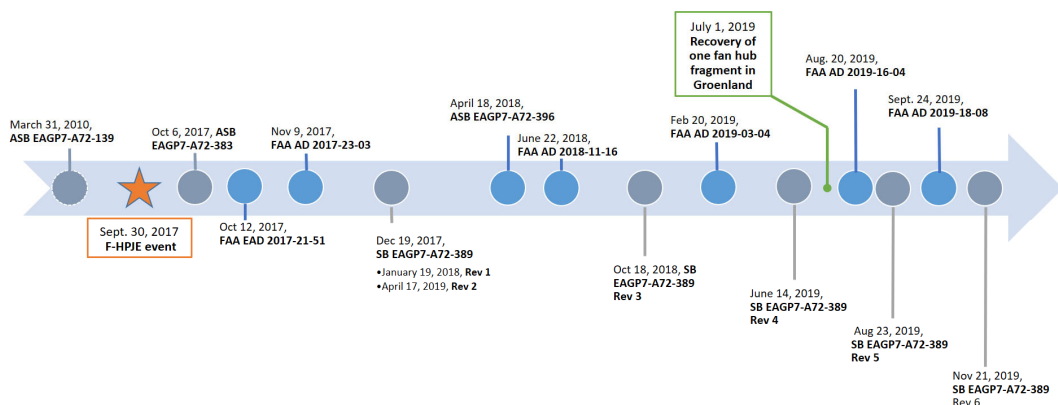
Figure 27: publication sequence of documents concerning fan hub inspection (time scale not respected)

These inspections were decided on without knowing the failure mechanism identified later during the examination of the fan hub fragment from engine No 4, on the assumption that the origin of the crack was on the surface and on the front face of the part. In the scope of the continuing airworthiness of A380 aeroplanes equipped with GP7270s and given the information and tools available at this point, the fan hubs were to be inspected to check that there were no cracks. Some of these inspections were extended to engines equipping other A380s.

The visual inspections required by the first SB published after the accident detected several cases of damage on the front faces of fan hubs. In particular, damage 0.30 mm (0.012 inches) deep was found in a scallop. This zone is subject to the highest stresses in service. This damage was most certainly due to an object striking the front face of the hub. The use of inappropriate tools during blade removal maintenance actions could cause similar damage.

Several Service Bulletins (SB) were published by the manufacturer after the accident requiring in-service inspections to be carried out. These inspections focused on the detection of potential damage in the fan hub regions which the manufacturer had identified as critical in terms of stress levels. The manufacturer's SBs were adopted by ADs issued by the FAA and EASA.

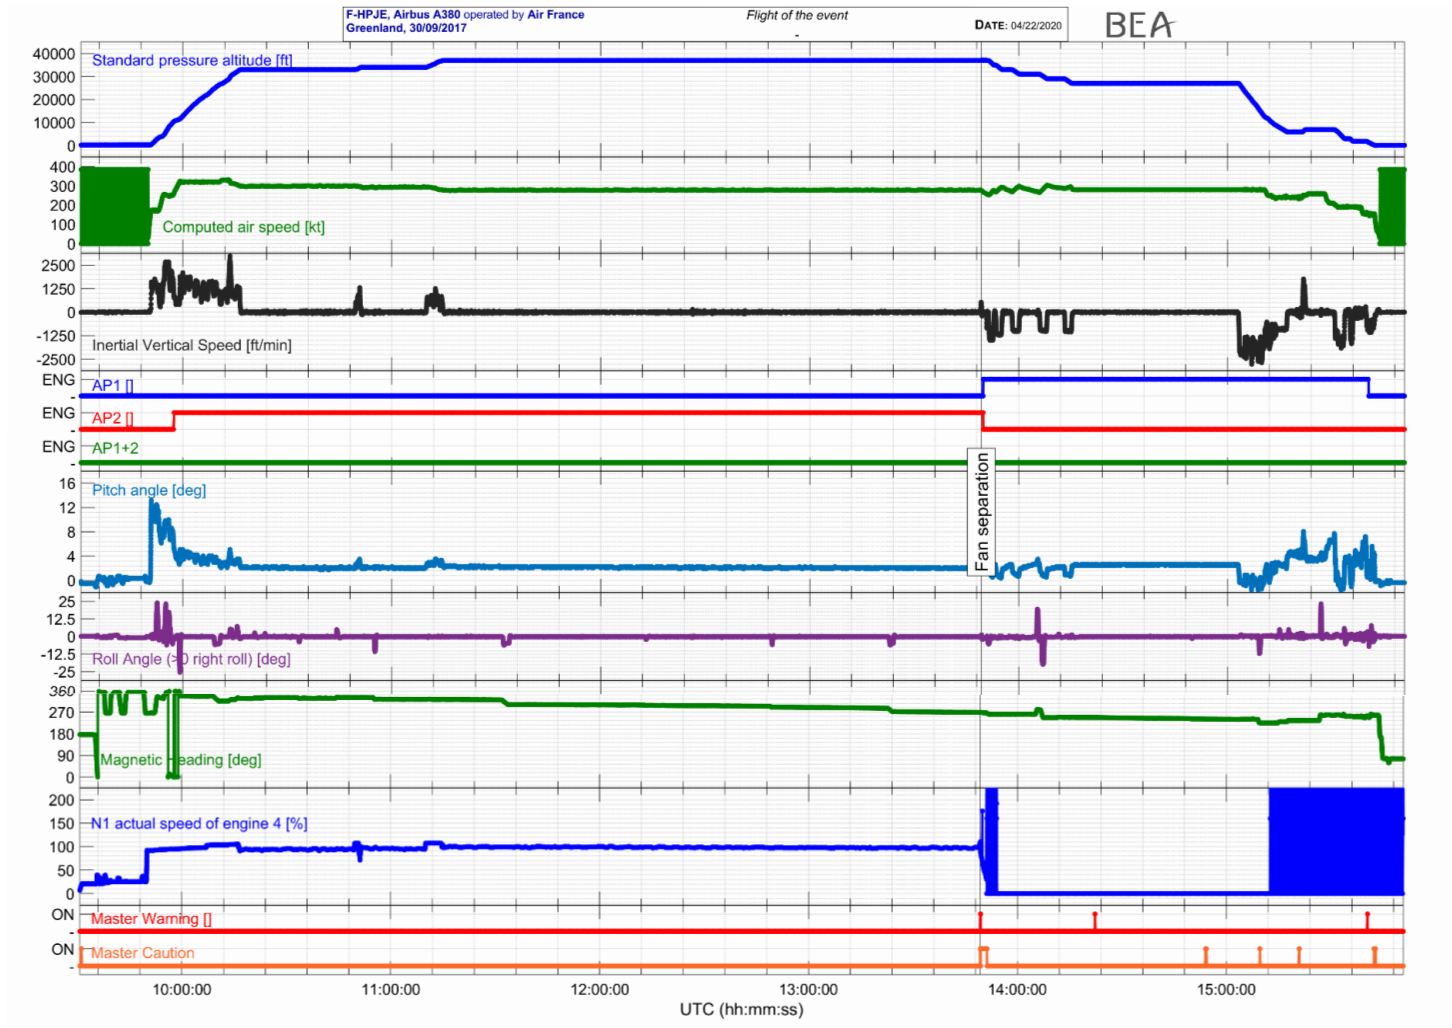
Figure 28: Occurrence flight

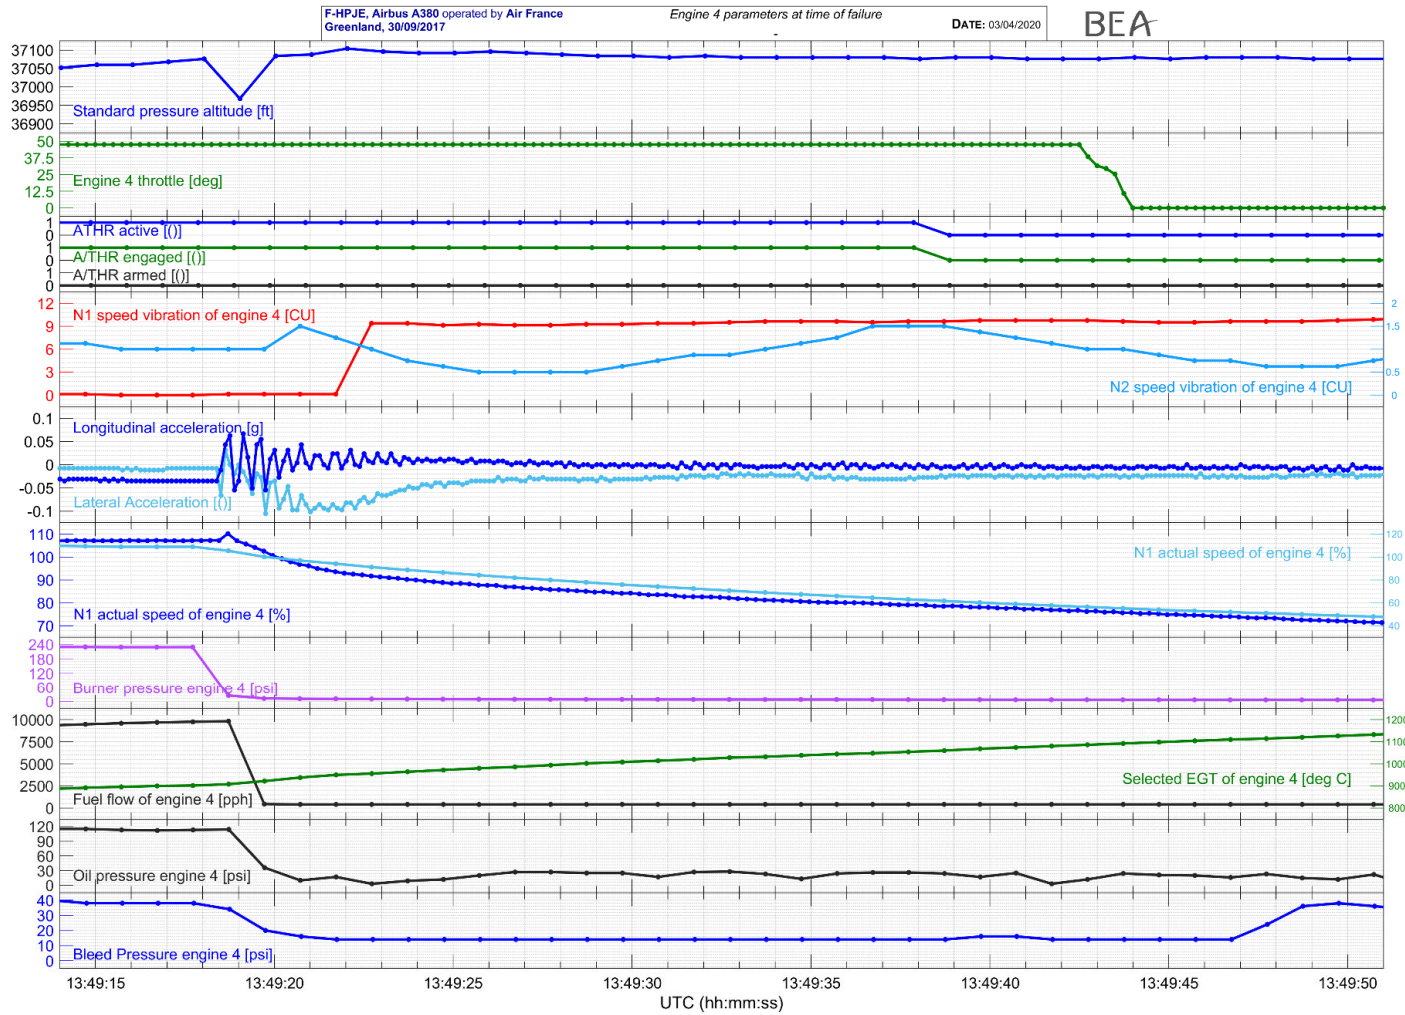
Figure 29: Engine No 4 parameters at time of failure

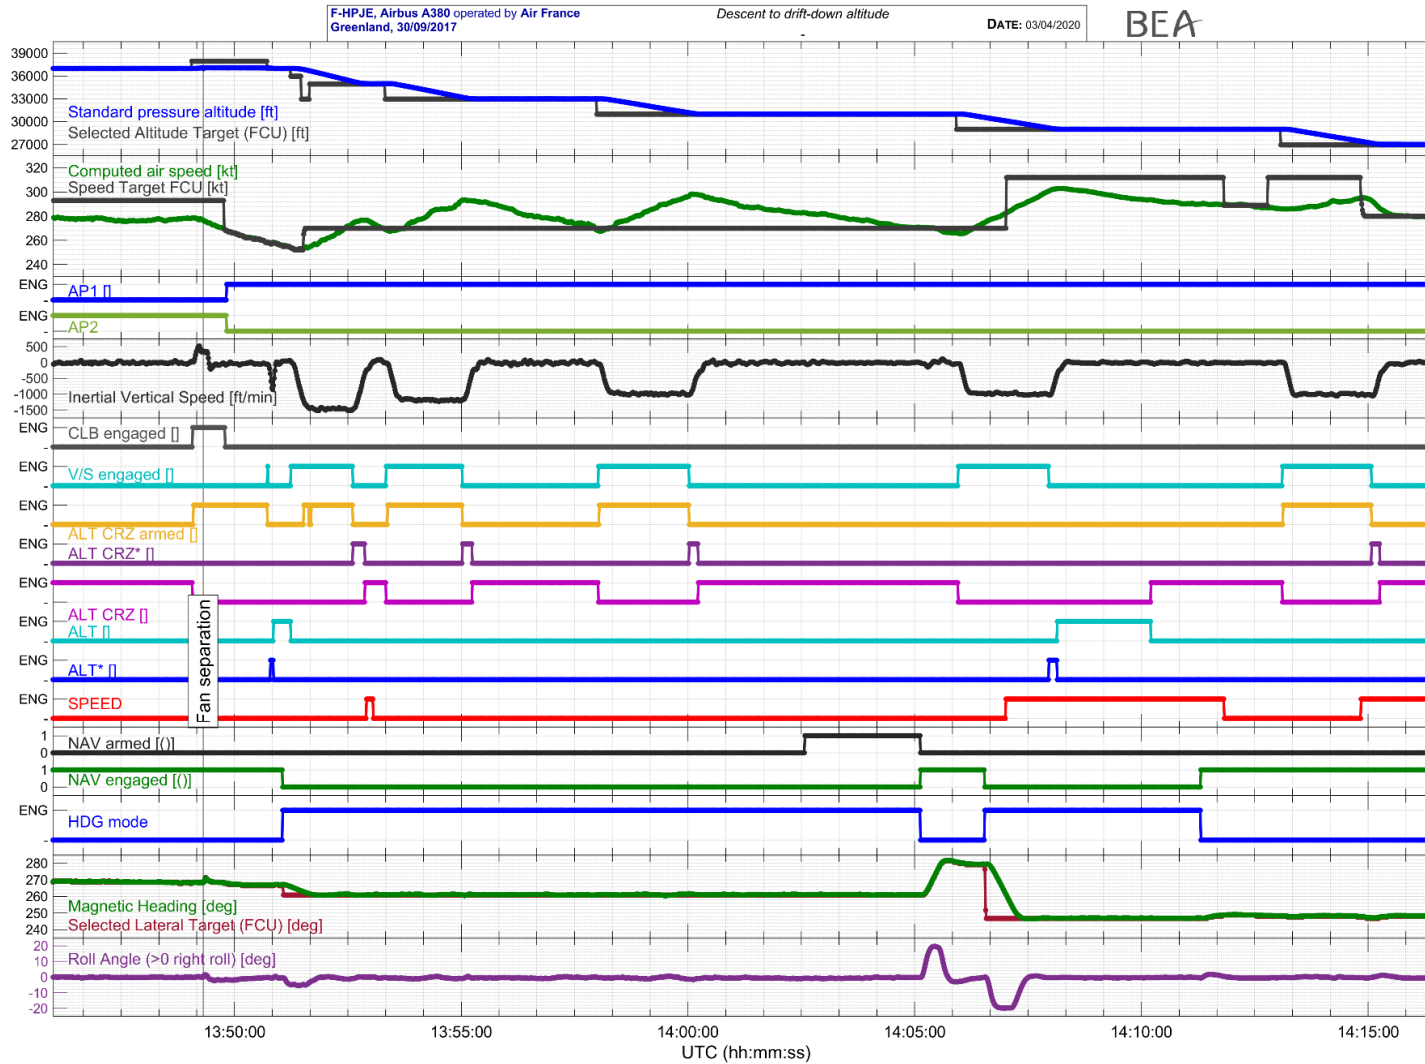
Figure 30: Descent to FL 270

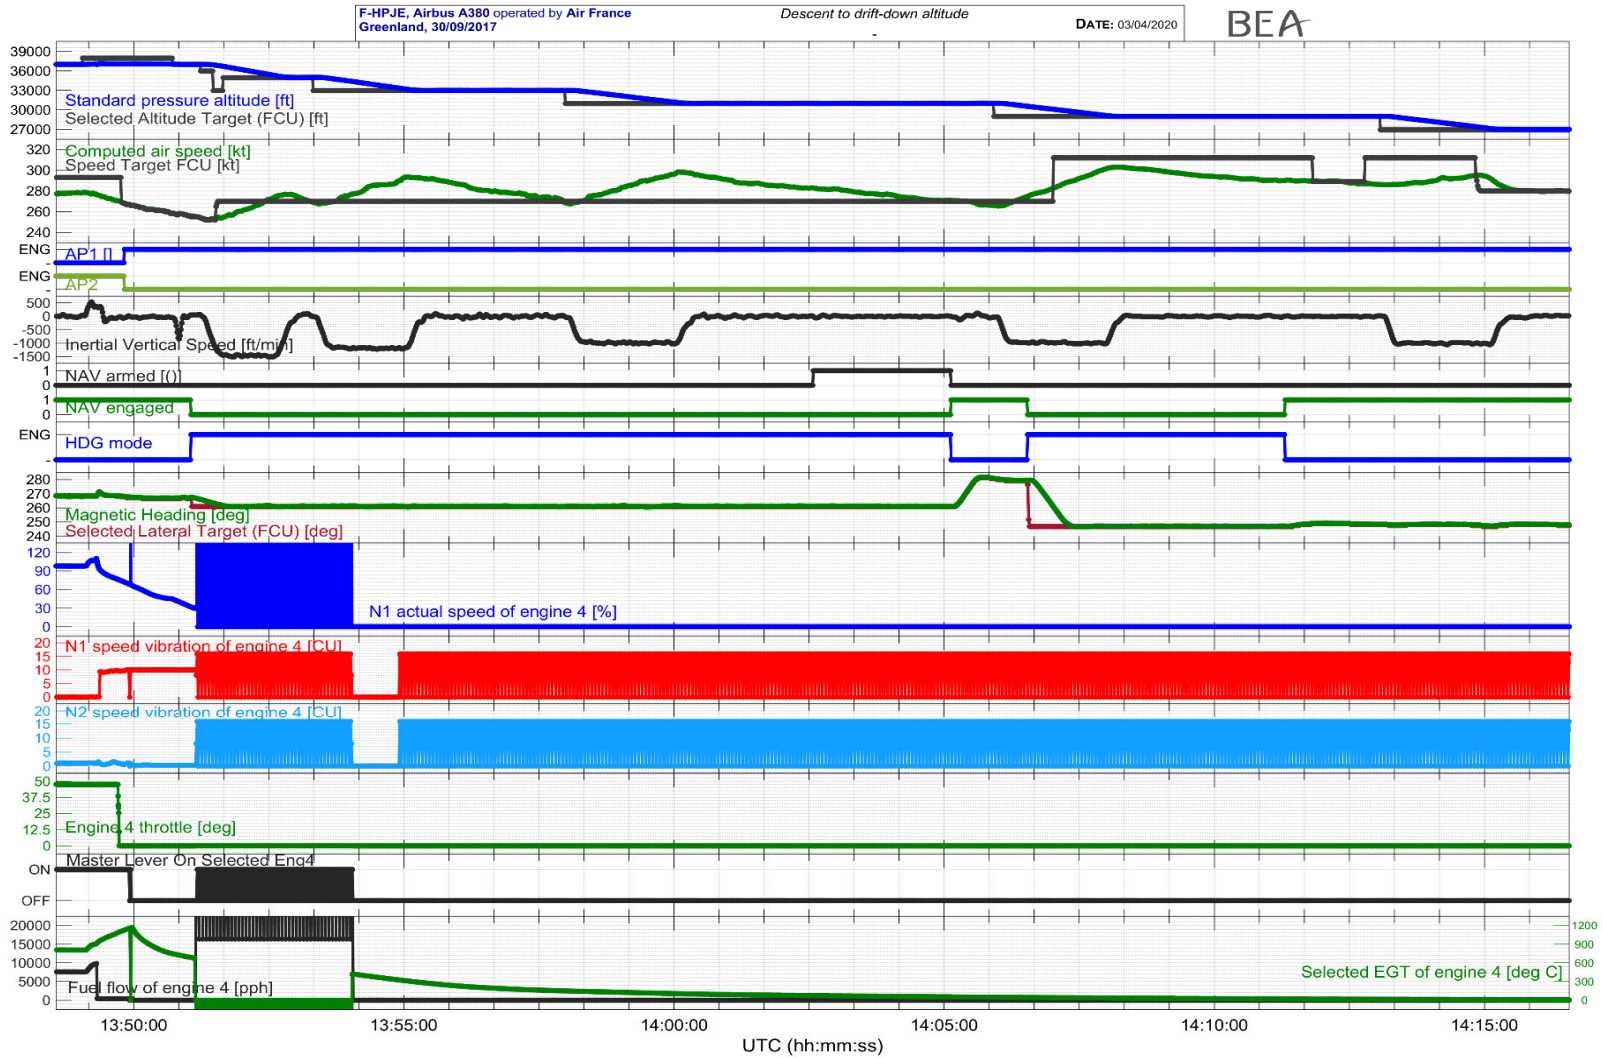
Figure 31: Engine 4 parameters during descent to FL 270
